FORENSIC INSPECTION

Forensic ROOF® Inspection

Report No :
127462

Property Inspected :
1000 Main Street
Anytown, CA, 90000

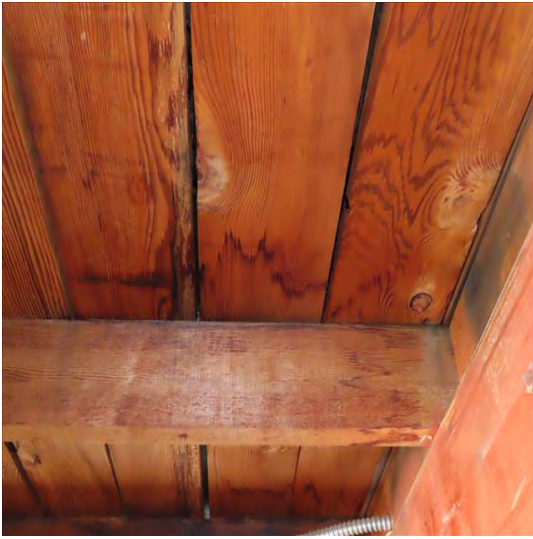
Image Number: 1

Observation: Picture of ceiling in garage area. Observed moisture stains in multiple locations in the garage area. This is evidence of moisture intrusion.

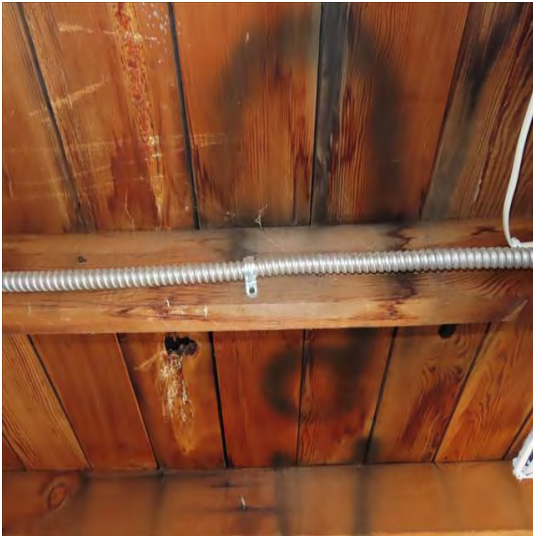
Image Number: 2

Observation: Picture of ceiling in garage area. Observed moisture stains in multiple locations in the garage area. This is evidence of moisture intrusion.

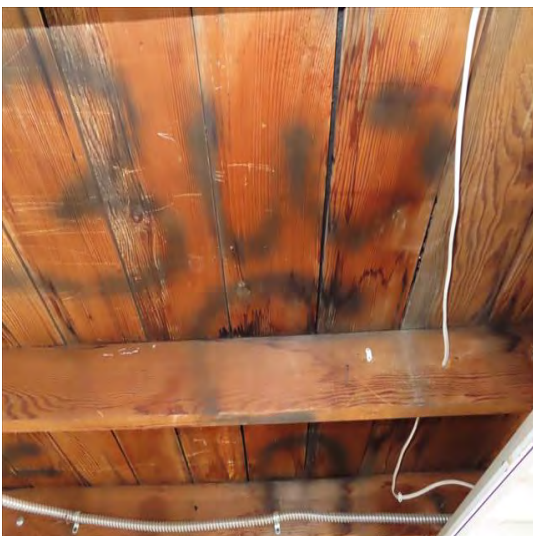
Image Number: 3

Observation: Picture of ceiling in garage area. Observed moisture stains in multiple locations in the garage area. This is evidence of moisture intrusion.

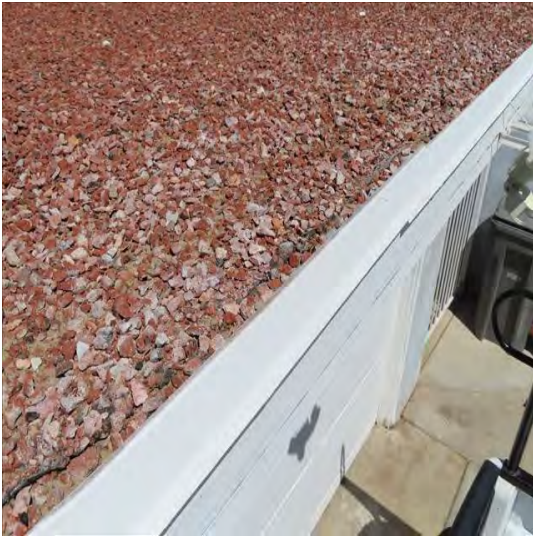
Image Number: 4

Determination: Normal Wear and Tear (Image Number: [4](#), [6](#), [7](#), [8](#), [9](#), [10](#), [11](#))

Observation: Picture of edge metal on the perimeter of the low slope roof system. **Storm related damage was not observed.** Observed roofing material pulling away from the edge metal. This is evidence that the roof system is at the end of its serviceable lifespan and should be replaced. **This area has a high likelihood of moisture intrusion and is most likely the cause of the moisture intrusion in the garage area.**

Cause: Normal wear and tear.

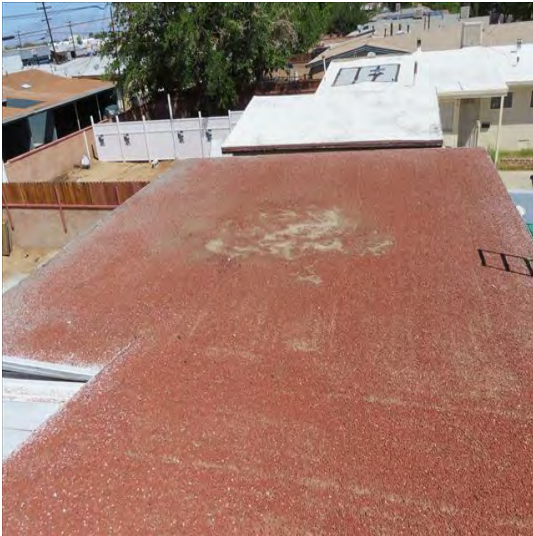
Image Number: 5

Observation: Overview of the low slope roof system above the moisture intrusion in the garage area. **Storm related damage was not observed.** Typical lifespan of this type of roof system is 15-20 years from date of installation. **This roof system appears to be at the end of its serviceable lifespan and should be replaced.**

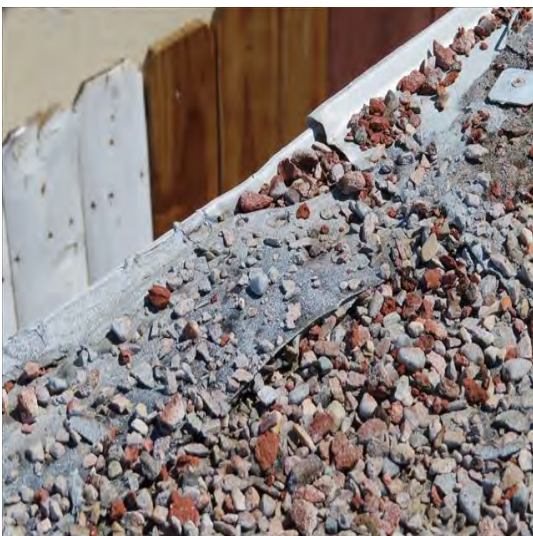
Image Number: 6

Observation: Picture of edge metal on the perimeter of the low slope roof system. **Storm related damage was not observed.** Observed roofing material pulling away from the edge metal. This is evidence that the roof system is at the end of its serviceable lifespan and should be replaced. **This area has a high likelihood of moisture intrusion and is most likely the cause of the moisture intrusion in the garage area.**

Cause: Normal wear and tear.

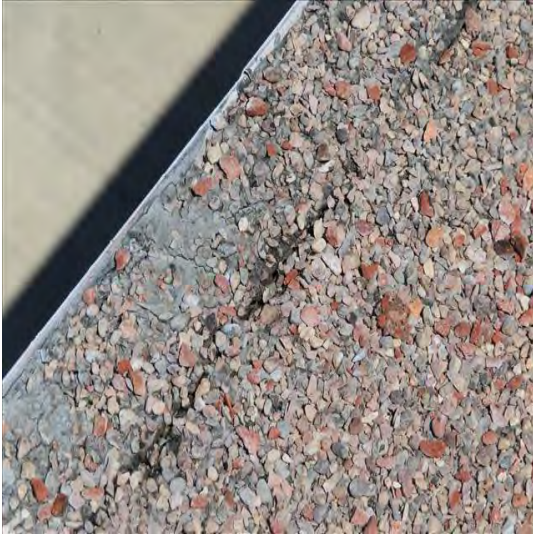
Image Number: 7

Observation: Picture of edge metal on the perimeter of the low slope roof system. **Storm related damage was not observed.** Observed roofing material pulling away from the edge metal. This is evidence that the roof system is at the end of its serviceable lifespan and should be replaced. **This area has a high likelihood of moisture intrusion and is most likely the cause of the moisture intrusion in the garage area.**

Cause: Normal wear and tear.

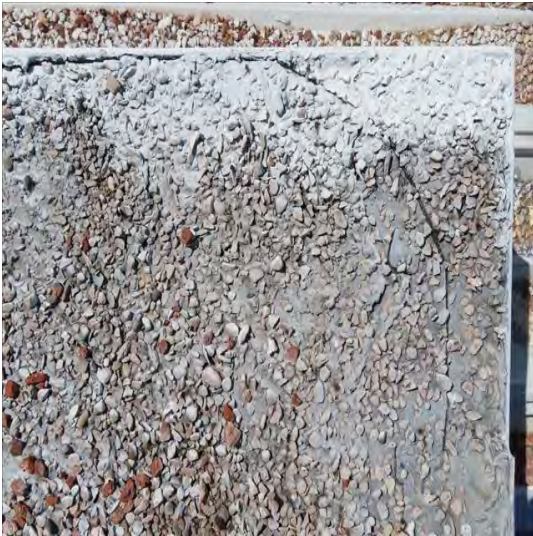
Image Number: 8

Observation: Picture of edge metal on the perimeter of the low slope roof system. **Storm related damage was not observed.** Observed roofing material pulling away from the edge metal. This is evidence that the roof system is at the end of its serviceable lifespan and should be replaced. **This area has a high likelihood of moisture intrusion and is most likely the cause of the moisture intrusion in the garage area.**

Cause: Normal wear and tear.

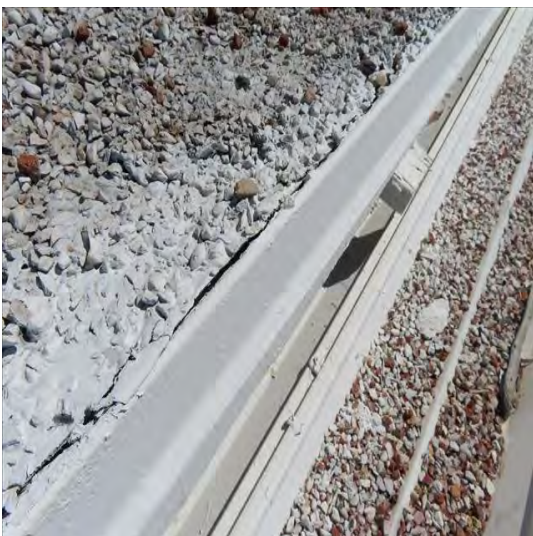
Image Number: 9

Observation: Picture of edge metal on the perimeter of the low slope roof system. **Storm related damage was not observed.** Observed roofing material pulling away from the edge metal. This is evidence that the roof system is at the end of its serviceable lifespan and should be replaced. **This area has a high likelihood of moisture intrusion and is most likely the cause of the moisture intrusion in the garage area.**

Cause: Normal wear and tear.

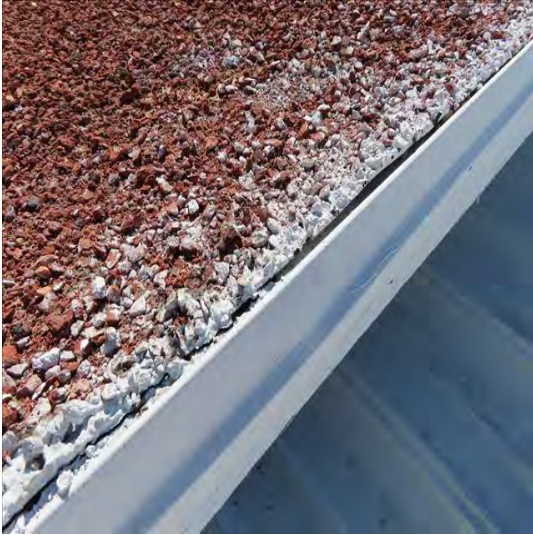
Image Number: 10

Observation: Picture of edge metal on the perimeter of the low slope roof system. **Storm related damage was not observed.** Observed roofing material pulling away from the edge metal. This is evidence that the roof system is at the end of its serviceable lifespan and should be replaced. **This area has a high likelihood of moisture intrusion and is most likely the cause of the moisture intrusion in the garage area.**

Cause: Normal wear and tear.

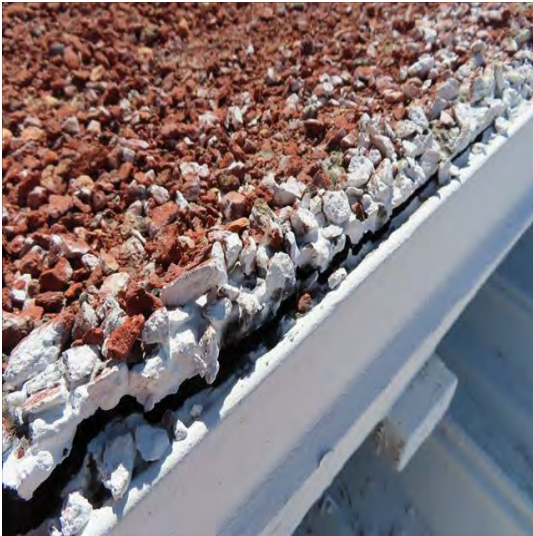
Image Number: 11

Observation: Picture of edge metal on the perimeter of the low slope roof system. **Storm related damage was not observed.** Observed roofing material pulling away from the edge metal. This is evidence that the roof system is at the end of its serviceable lifespan and should be replaced. **This area has a high likelihood of moisture intrusion and is most likely the cause of the moisture intrusion in the garage area.**

Cause: Normal wear and tear.

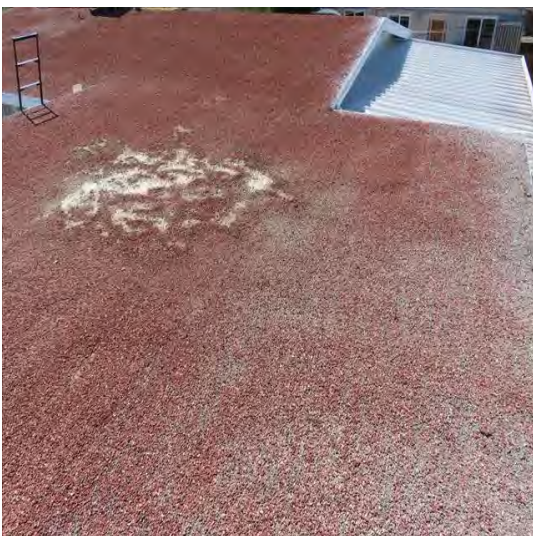
Image Number: 12

Observation: Overview of the low slope roof system above the moisture intrusion in the garage area. **Storm related damage was not observed.** Typical lifespan of this type of roof system is 15-20 years from date of installation. **This roof system appears to be at the end of its serviceable lifespan and should be replaced.**

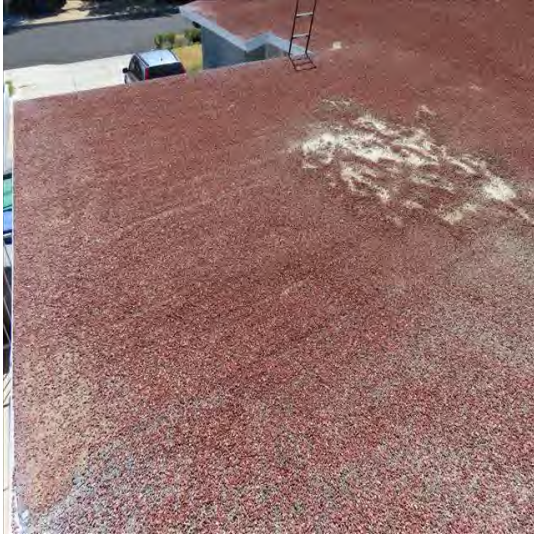
Image Number: 13

Observation: Overview of the low slope roof system above the moisture intrusion in the garage area. **Storm related damage was not observed.** Typical lifespan of this type of roof system is 15-20 years from date of installation. **This roof system appears to be at the end of its serviceable lifespan and should be replaced.**
